Clavicle Fracture Solutions - Case Series

Locking Clavicle Plating System

Dual-Trak Clavicle Screw System

Case Series: Clavicle Fracture Solutions

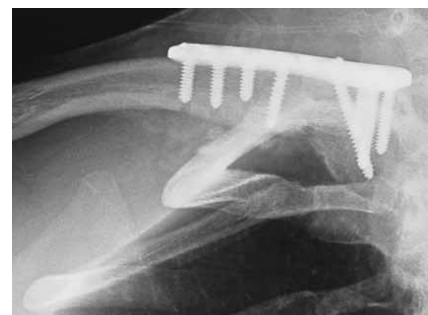
Figure 3: Postoperative Radiograph

The A/P radiograph shows anatomic restoration of the clavicle (Figure 3). Multiple screws were able to be placed medially into the medial head fragment and the locking/nonlocking screws were placed laterally into the shaft. This restored the anatomy and took away the prominence that the patient had preoperatively due to the amount of separation.

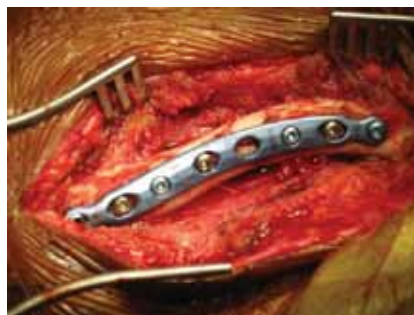
Figure 2: Intraoperative photograph

Because of the amount of displacement of the fracture, the clavicle is stabilized with an Acumed® precontoured 8-Hole Locking Superior Clavicle Plate and 3.5 mm locking and nonlocking screws. In this instance, one of the oblong compression slots in the center part of the plate was left devoid of a screw and used to help lag the fracture

fragments. In particular, the lag screw captured and stabilized the butterfly fragment. It is important to note the utility of the precontoured plate as a template to help facilitate reduction of the complex S-shaped curve of the clavicle (Figure 2).

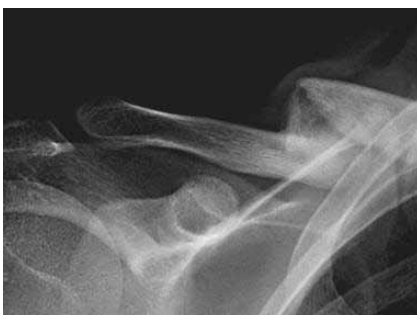
Figure 1: Preoperative Radiograph

Visual observation showed the medial fragment was tenting the skin causing severe pain and soft-tissue irritation. Physical examination confirmed inferior and medial displacement of her right shoulder girdle compared to her left. The medial and lateral fragments overlapped approximately 20 mm, causing marked clinical deformity. Additionally, the patient was experiencing crepitus and a limited range of motion. Subsequent radiographs showed the severe superior displacement of the medial fragment in relation to the lateral fragment (Figure 1).

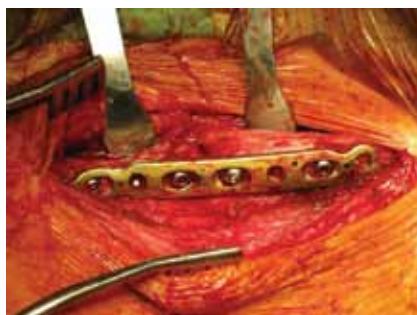
Figure 2: Intraoperative photograph

In this instance, an Acumed® 8-Hole Locking Anterior Clavicle Plate was utilized for several reasons (Figure 2). First, the oblique fracture pattern facilitated the use of an anterior plate for lack of fixation superiorly. Second, given the shape of the patient's clavicle, an anterior approach allowed for greater screw purchase. Third, the anterior-posterior plane is ideal for lag screw fixation through the anterior placed clavicle plate. Finally, as the patient was very thin, anterior placement of the plate decreased the potential for soft-tissue irritation from a book bag or purse over the top of her shoulder.

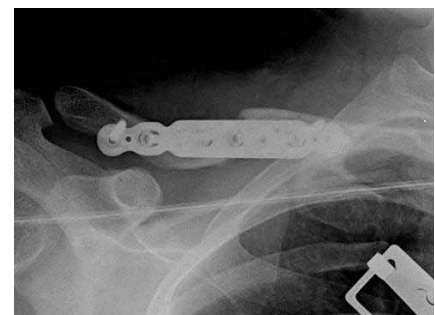
Figure 3: Postoperative Radiograph

The A/P Radiograph confirms reduction of the clavicle fracture with the Acumed® Locking Anterior Clavicle Plate (Figure 3). The medial fragment is now aligned with the lateral fragment, as opposed to the severe step-off that the patient had preoperatively.
